Environmental Impact Assessment of Solid Waste Disposal on Groundwater Quality

This study focuses on the impact of solid waste on groundwater quality in the region of Ramayanpatti, Tirunelveli. Tirunelveli city generates 100 tonnes of solid waste in a day. Solid waste has organic matter, inorganic matter, and moisture content which leaches dissolved organic matter, and heavy metals to the groundwater. Rainfall runoff carries all the dissolved contaminants from the solid waste and infiltrates into the groundwater. Groundwater quality is characterized at 30 locations around the dumping yard. Water Quality Index(WQI) is calculated

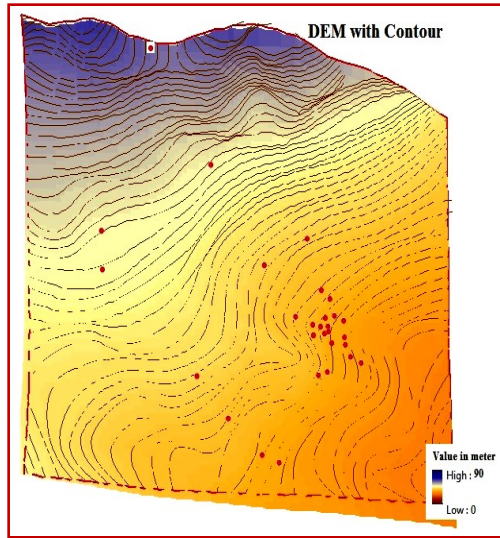
Figure 3: Sampling point locations

A reconnaissance survey has been undertaken to identify the sampling points in and around the dumpsite. Thirty sampling points have been identified, and most of the points lie in the aquifer movement of groundwater from the dumpsite. Groundwater samples were collected from various sample points in the study area. Groundwater samples from tube wells/bore wells were collected in and around the study area at 30 locations, and the samples were subjected to a comprehensive physicochemical analysis. These locations have been identified based on the growth of residential area at Ramayanpatti village which is on the out skirts of the Tirunelveli city around the dump yard as well as from DEM topography image. The sampling point locations and digital elevation model are shown in Fig 2 and Fig 3 respectively. Google images of solidwaste dump yards and Waste stabilization ponds which are nearby are shown in Fig 4 and Fig 5 respectively. The area selected for our study is 10x10 km.

The sampling points were marked as W1 to W30 as shown in Fig.2. Geo referencing of sampling points are given in the Table 1. Groundwater sampling is done for four consecutive months on the onset of monsoon. Samples have been stored and preserved as per the sampling methods of the Standard methods for Examination of Water and Wastewater, American Public Health Association (APHA manual). Groundwater sample is analyzed for ten chemical parameters. The procedure adopted for characterization is as per the standard methods of titration, flame photometric and spectro-photometric methods of the APHA manual. Groundwater quality is assessed for drinking water standards as per Indian Standards 10500-2012 except potassium. The standard for potassium is taken from the guide lines of World Health Organization. The Water Quality Index is classified as very good, good, poor, very poor, and unfit. The spatial distribution of WQI is made using surfer software.

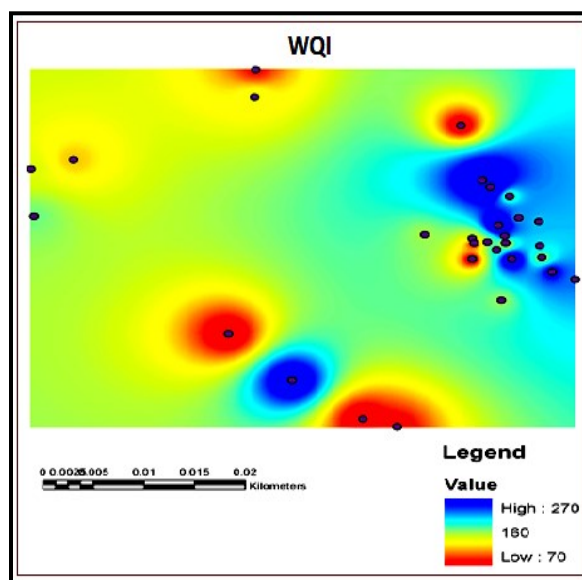
Figure 7. Spatial distribution of WQI

The spatial distribution of WQI shows that the solid waste dumping yard produces leachate and affects the groundwater quality. It is shown in the blue shade on the right-hand side of the image. The diminishing blue shade on the right of the image shows the movement of the leachate. The quality of groundwater is also very poor in the agriculture-practiced region as shown in the blue shade present at the bottom of figure 6 at sampling point 25 due to the use of chemical fertilizer. The region in the blue shade of the image, the water is unfit for drinking and shall be used for other domestic purposes.

Points W7, W8, W11, and W14 which are near a dump yard and pond have high WQI due to the leachates of solid waste and some extent to the liquid domestic waste from waste stabilization pond. Point W25 is affected due to the intensive practice of irrigation around the region. The water quality index shows that in most of the places, the water is poor to very poor, even unfit for drinking. The values of WQI show that the groundwater was contaminated with leachate in the direction of groundwater movement in the aquifer toward the Tamirabarani River as inferred from the digital elevation model of the study area. The area in and around point W25 is an agricultural practiced area and so it is contaminated with nutrients which is normally in use in agriculture practices.
